JARBIDGE RIVER STREAM CHANNEL INTEGRITY INVENTORY

Elko County, Nevada

Humboldt-Toiyabe National Forest
2035 Last Chance Road
Elko Nevada 89801
(Contract 53-0261-01-08, Task Order SWINAO-4)

February 2002

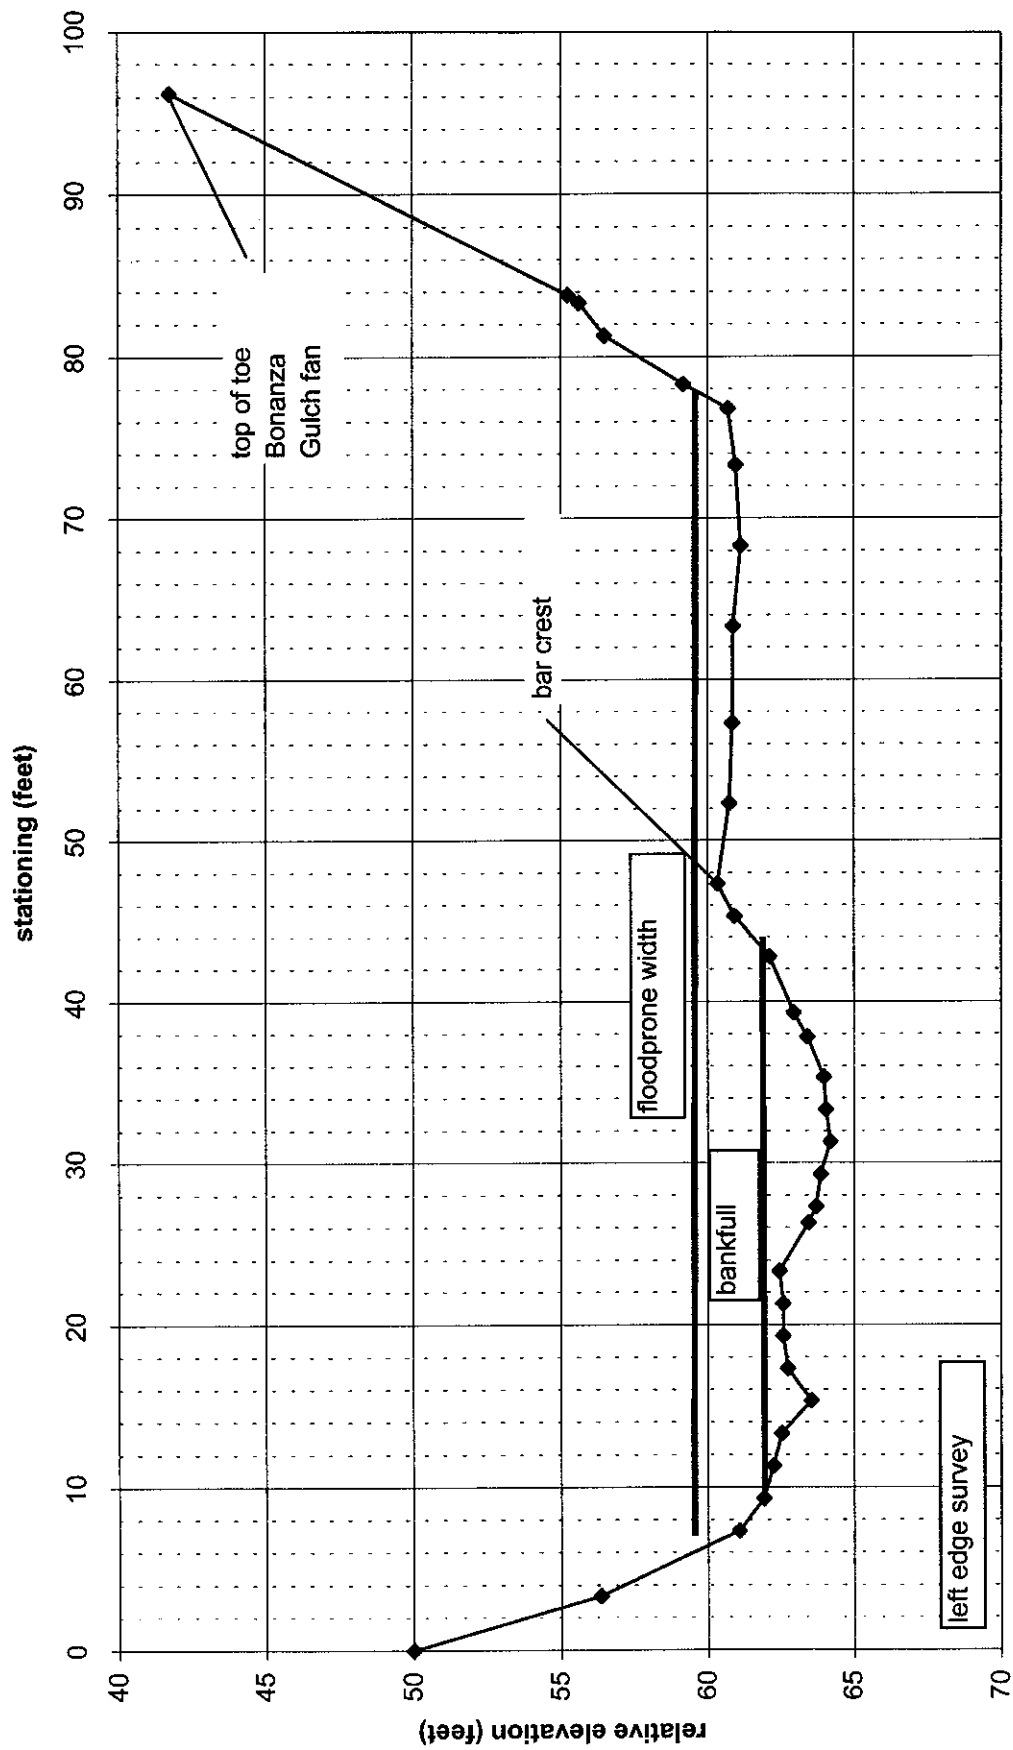
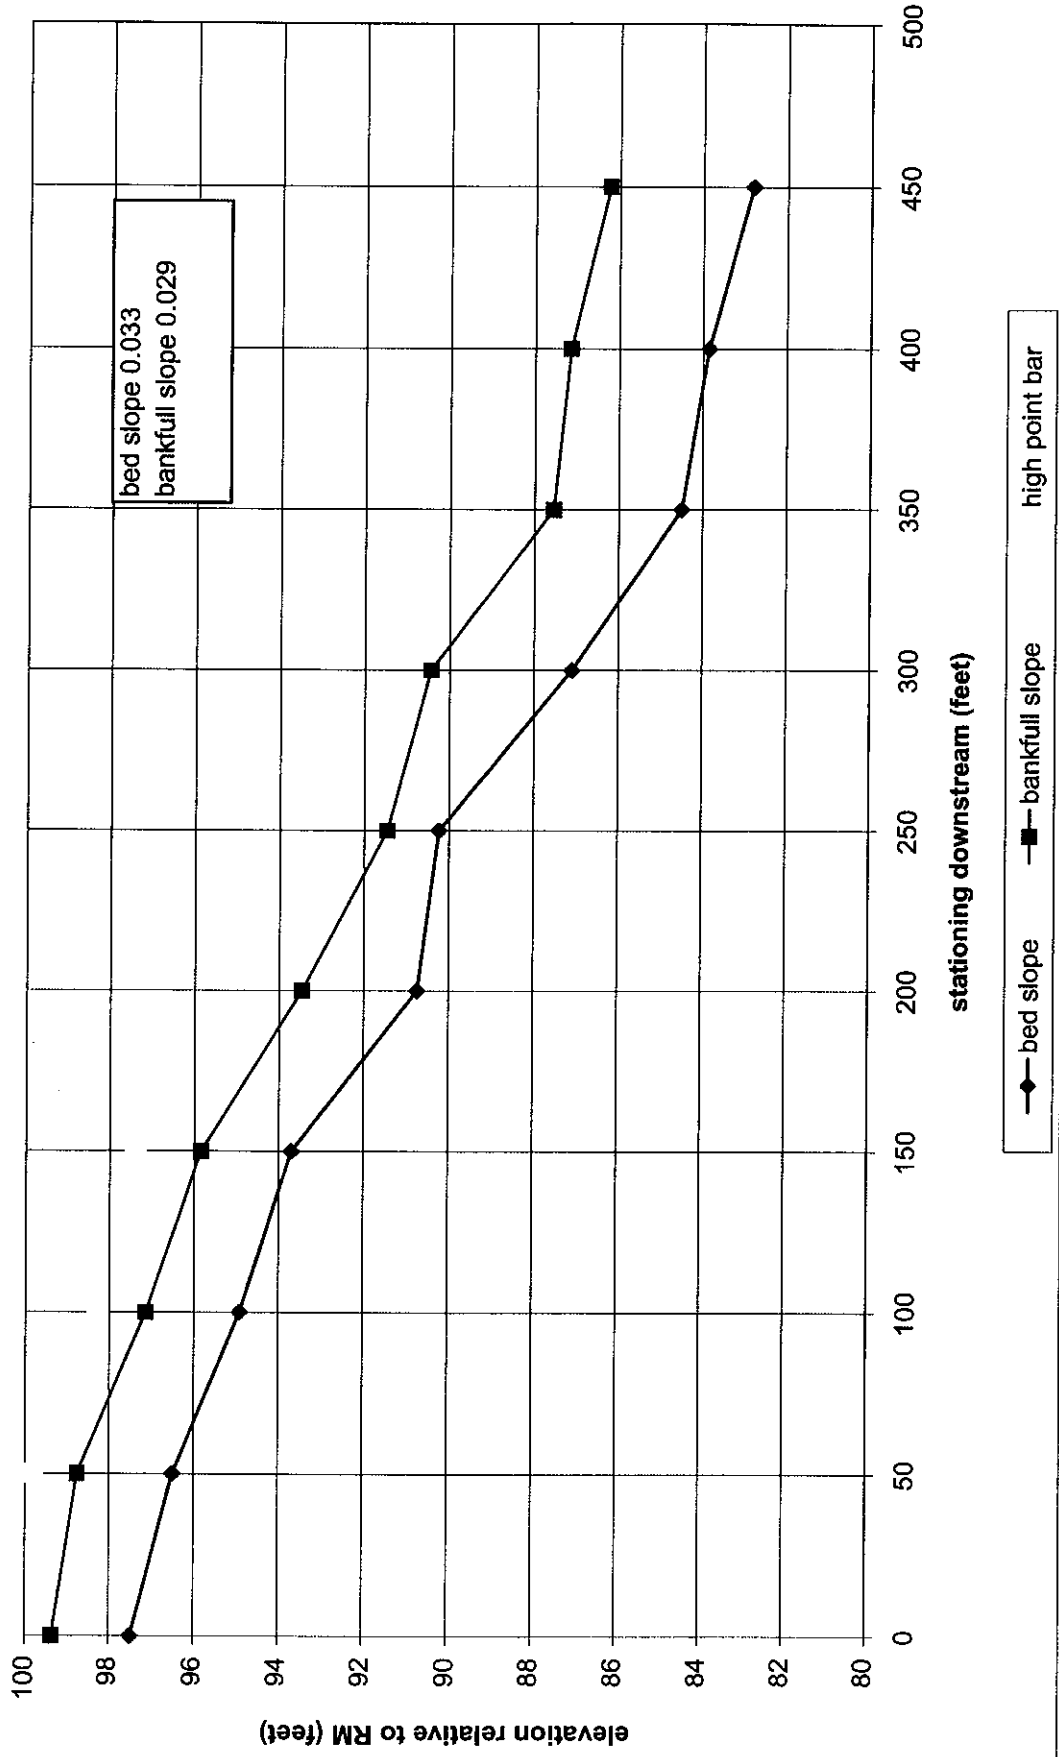
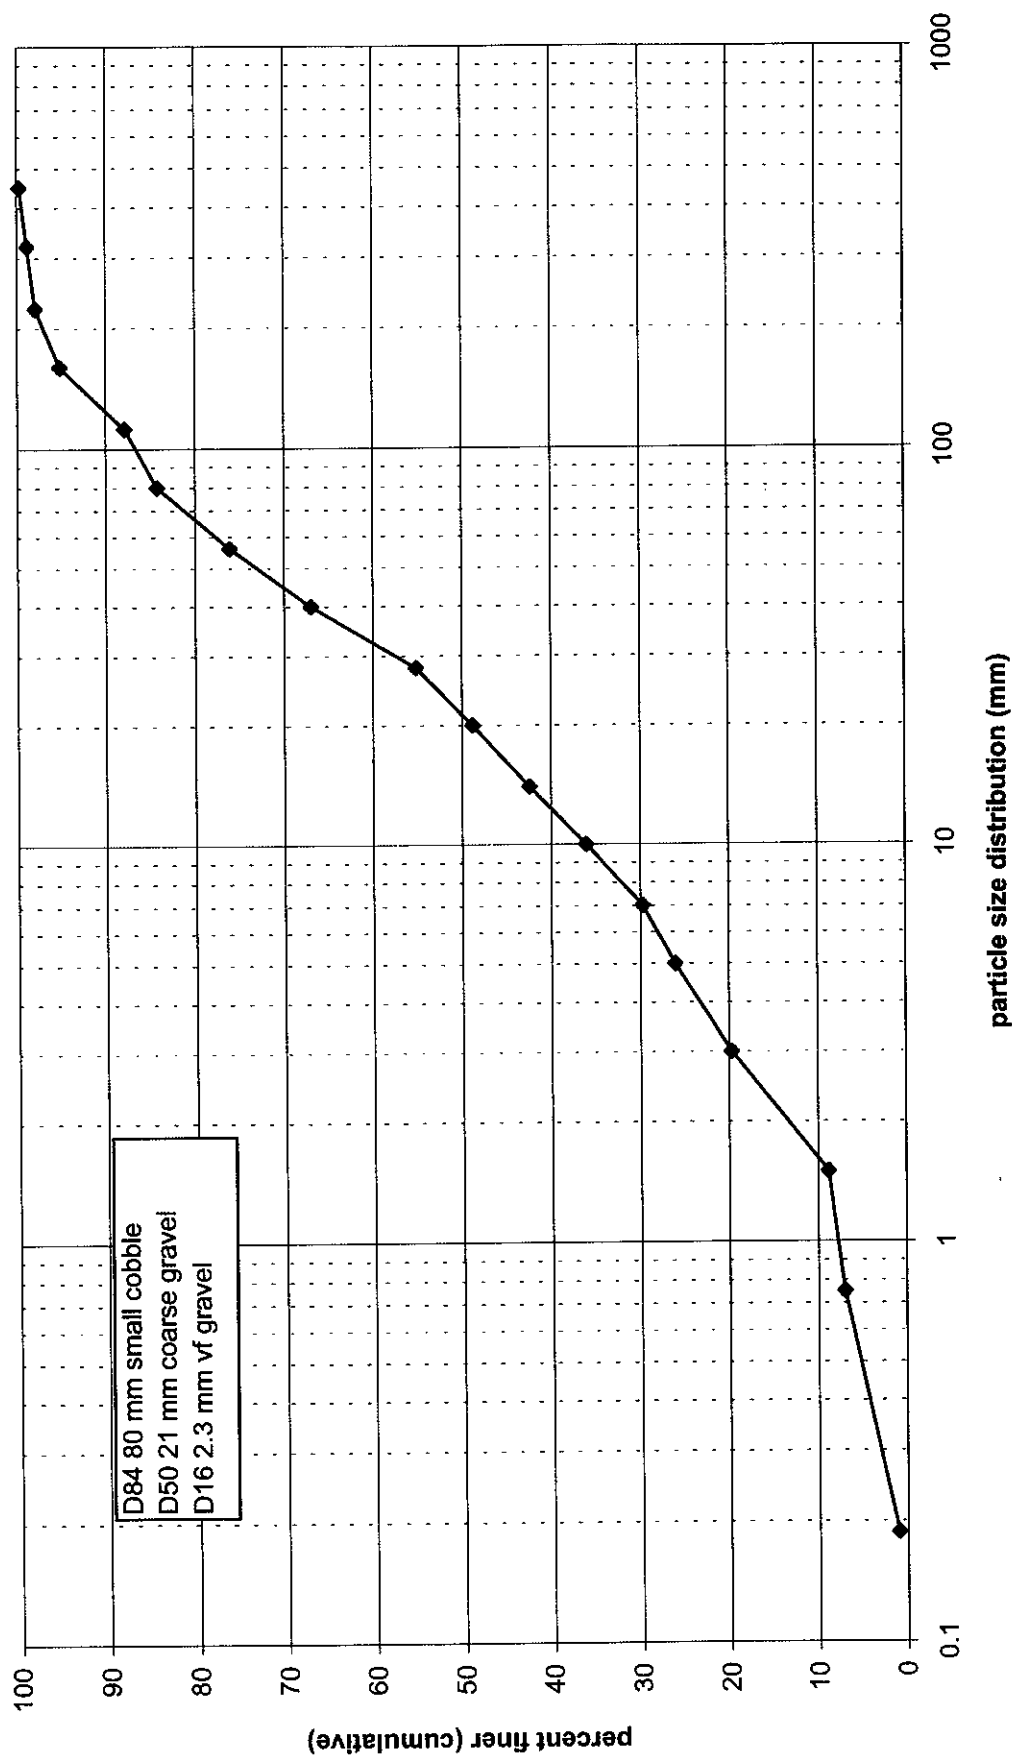
West Fork Jarbidge bl Bonanza Gulch survey reach Cross section #2 plot

<u>Bank Stability</u>	Side slopes of valley are actively eroding and are large source of sediment. Large debris fan erosion sources observed in all areas where active channel cuts through fans.	
<u>Woody Debris</u>	Breached woody debris jams located through reach. Large wood introduced from bank areas where active erosion is undermining trees. Does not appear that Bonanza Gulch is active contributor of large woody debris. Wood recruitment potential high due to unstable slopes.	
<u>Pools</u>	Small pocket water and scour pools observed through reach. Large substrate and wood increases instream hydraulic and habitat diversity.	
<u>Rosgen Classification Data</u>		
<u>Cross section form</u>	deep run bounded by recent, elevated bar deposits	
<u>Bankfull width</u>	33.5 feet	
<u>Mean bankfull depth</u>	1.5 feet	
<u>Maximum bankfull depth</u>	2.3 feet	
<u>Floodprone width</u>	72 feet	
<u>Bed slope</u>	0.033

<u>Bankfull slope</u>	0.029	
<u>Bed materials (D50)</u>	21 mm	
<u>Sinuosity</u>	1.1 est	
<u>Width/Depth ratio</u>	22	
<u>Entrenchment ratio</u>	2.1	
<u>Rosgen stream type</u>	B4	
<u>Summary</u>	Reach is dominated by hillslope and debris flow processes. Reach is representative of other reaches flowing through debris fan sediments. Primary source for wood recruitment into channel environment.

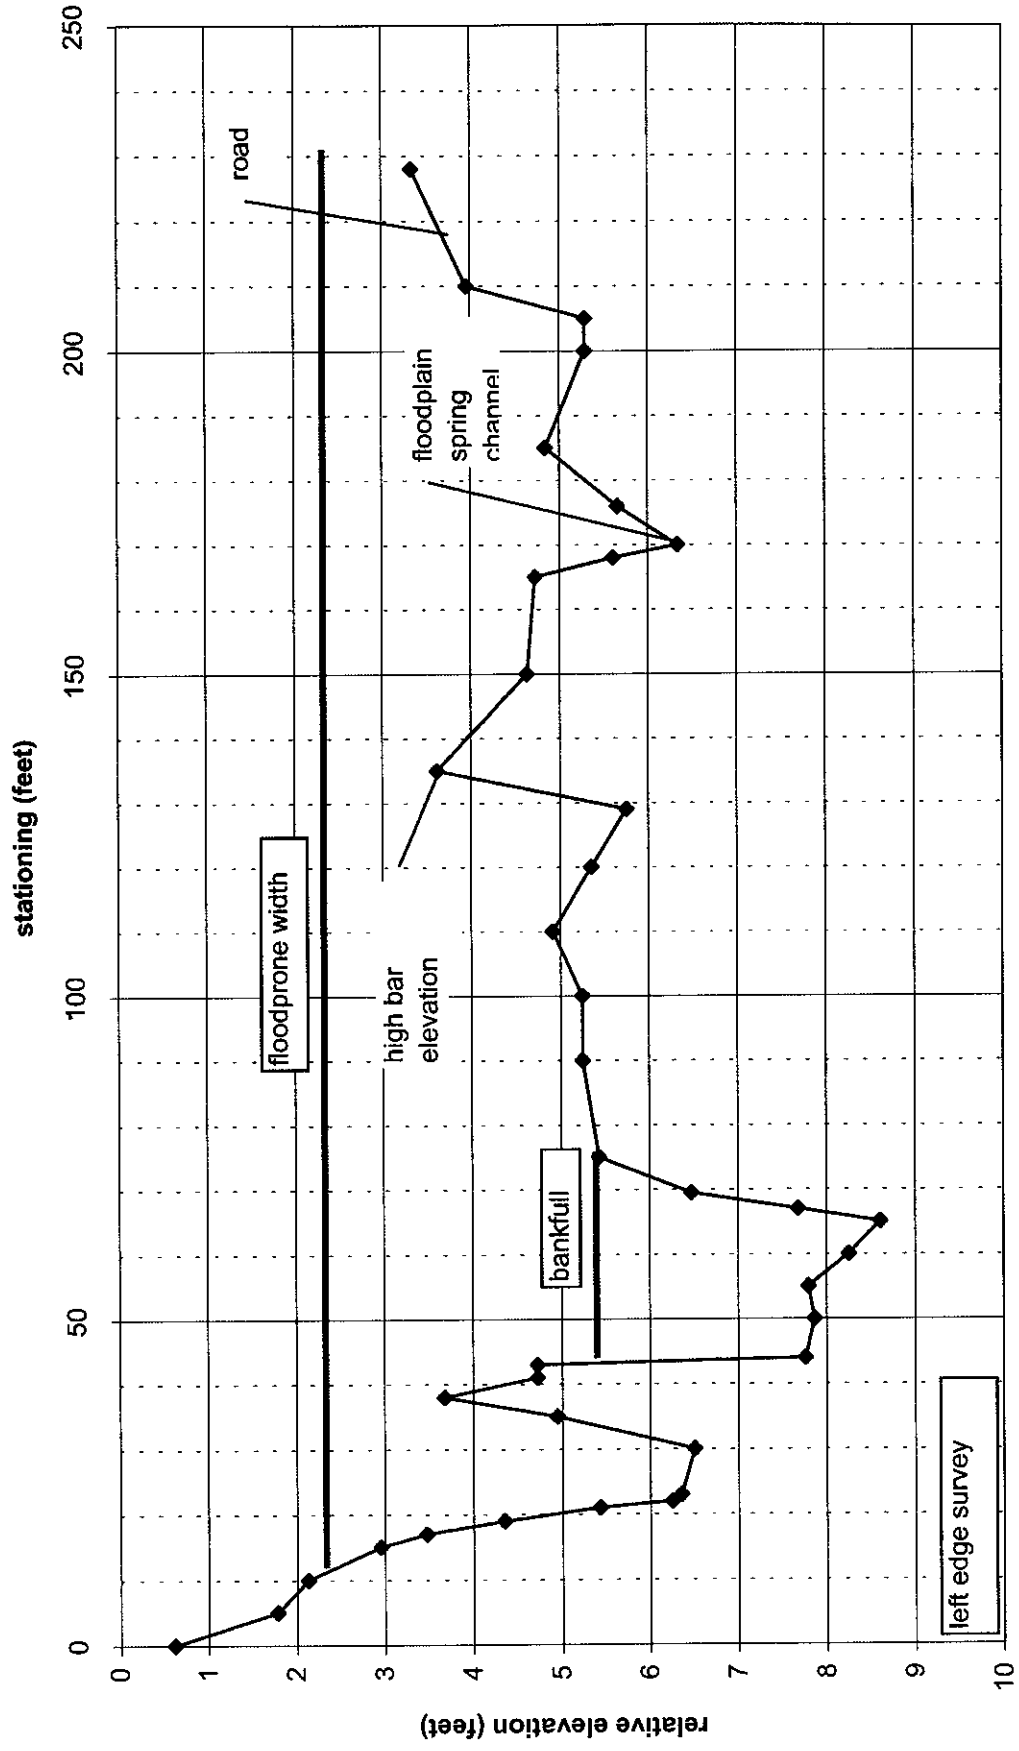
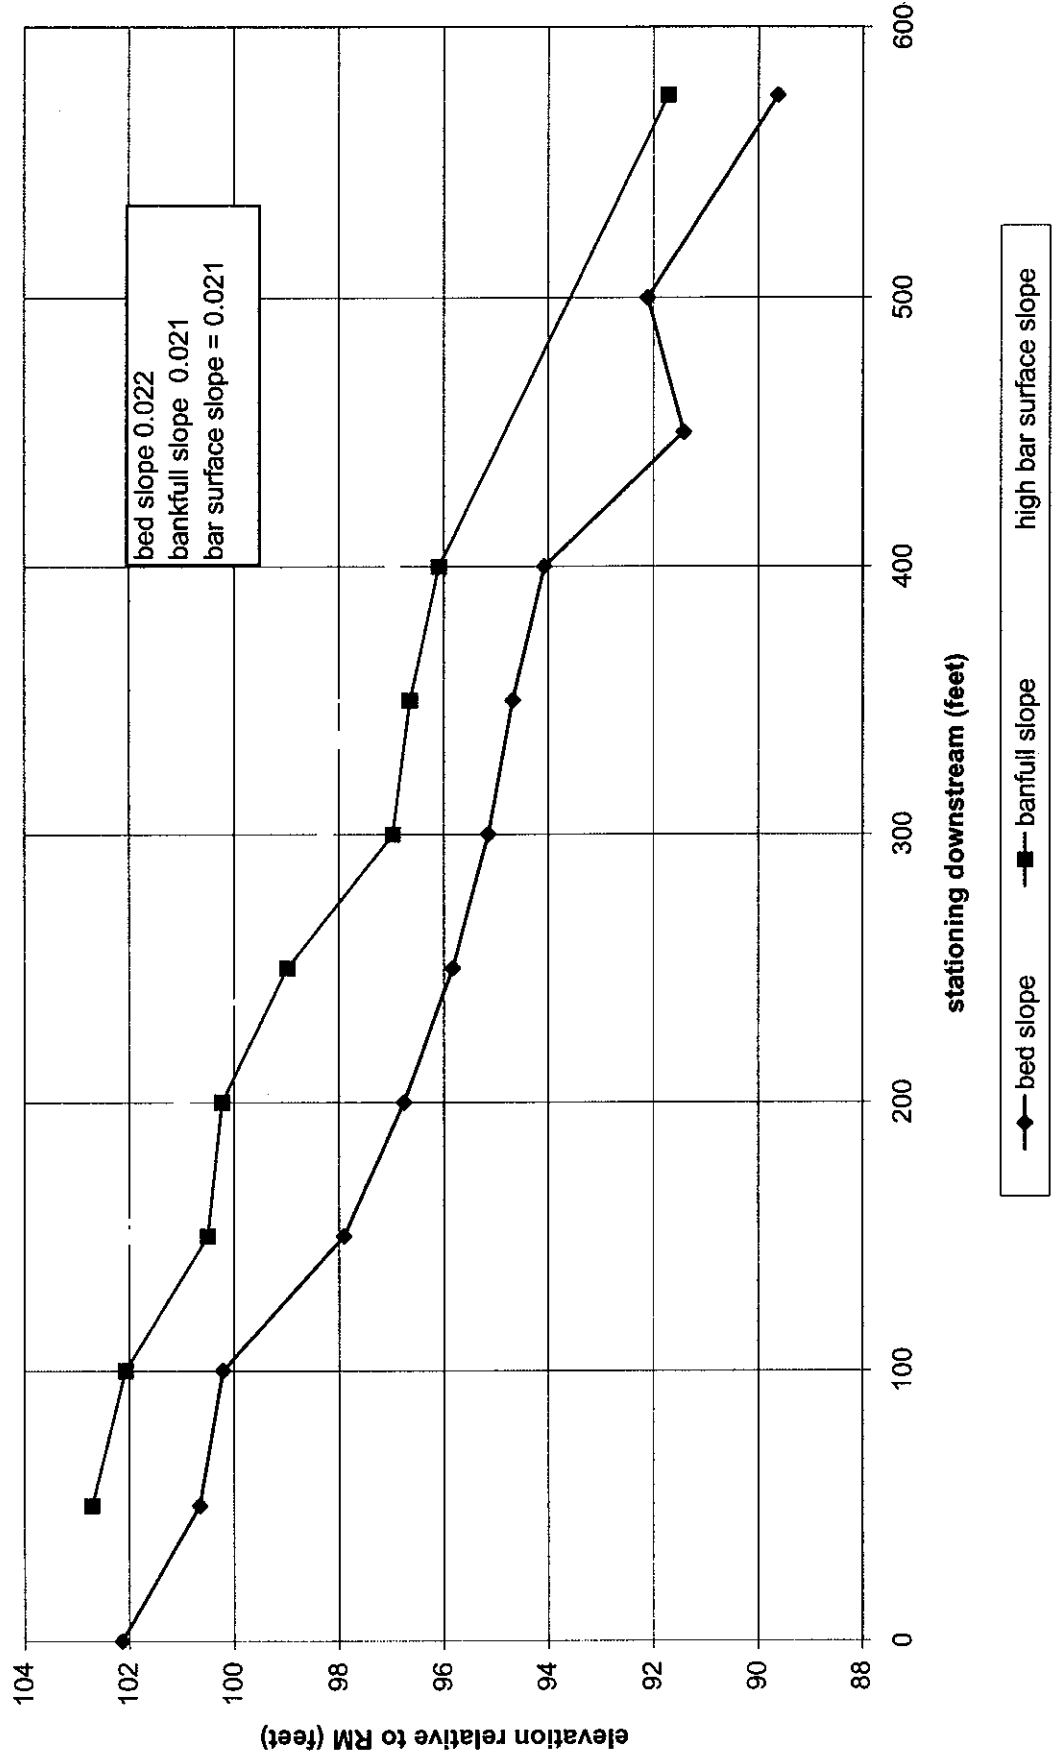
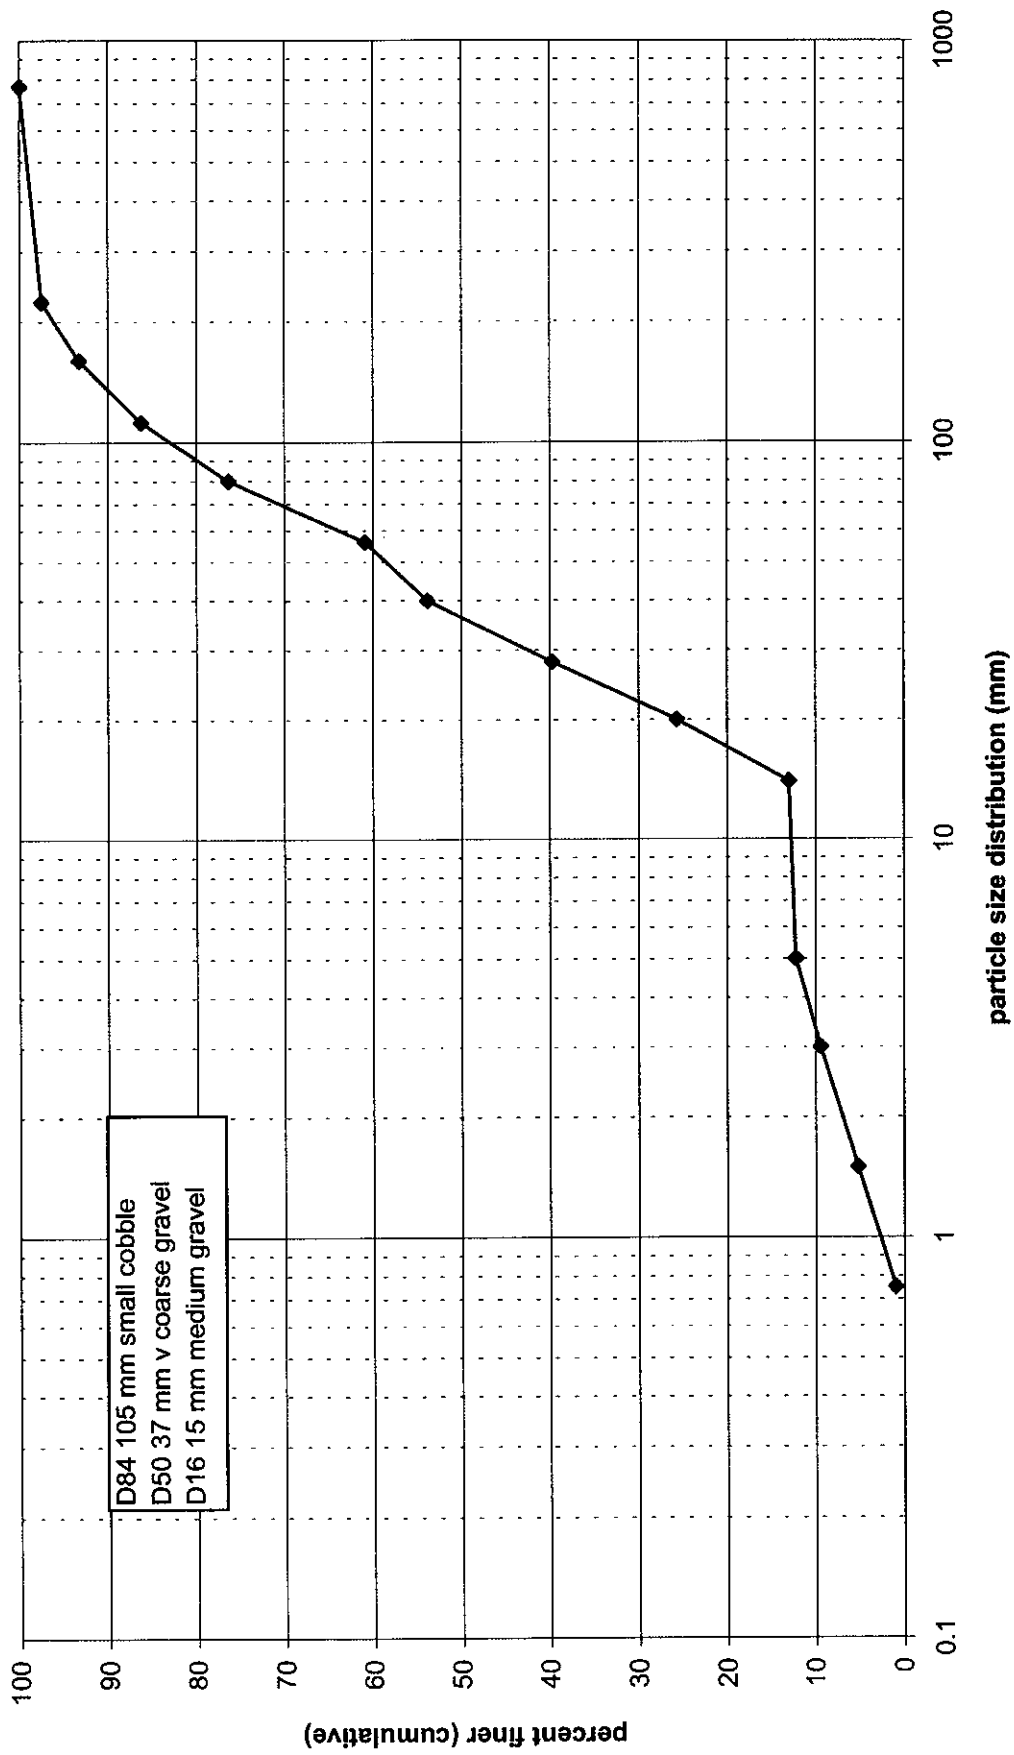
West Fork Jarbidge in vicinity of Mahoney Guard Station Cross section plot

<u>Bank Stability</u>	<p>Most channel banks are formed in poorly or unvegetated gravel bars. Banks materials form movable channel boundary, but are not active sediment sources due to depositional character of reach.</p>	
<u>Woody Debris</u>	<p>Limited areas of wood accumulation in channel. Shrub riparian community may form bank margins and create undercut areas. Limited wood recruitment potential.</p>	
<u>Pools</u>	<p>Generally very uniform channel units with very limited pool development. Some bank margin pools where riparian vegetation occurs.</p>	
<u>Rosgen Classification Data</u>		
<u>Cross section form</u>	uniform run flowing through gravels	
<u>Bankfull width</u>	31 feet	
<u>Mean bankfull depth</u>	2.1 feet	
<u>Maximum bankfull depth</u>	3.2 feet	
<u>Floodprone width</u>	240 feet	
<u>Bed slope</u>	0.022	
<u>Bankfull slope</u>	0.021	
<u>Bed materials (D50)</u>	37 mm	
<u>Sinuosity</u>	1.3 est	
<u>Width/Depth ratio</u>	14.8

<u>Entrenchment ratio</u>	7.7	
<u>Rosgen stream type</u>	C4b	
<u>Summary</u>	<p>Survey reach is representative of depositional reach starting downstream of Moore Gulch. Large sediment storage area. Reach is dominated by fluvial processes. Locally channel braids. Iron oxide staining from Greylock adit still evident in gravels.</p>

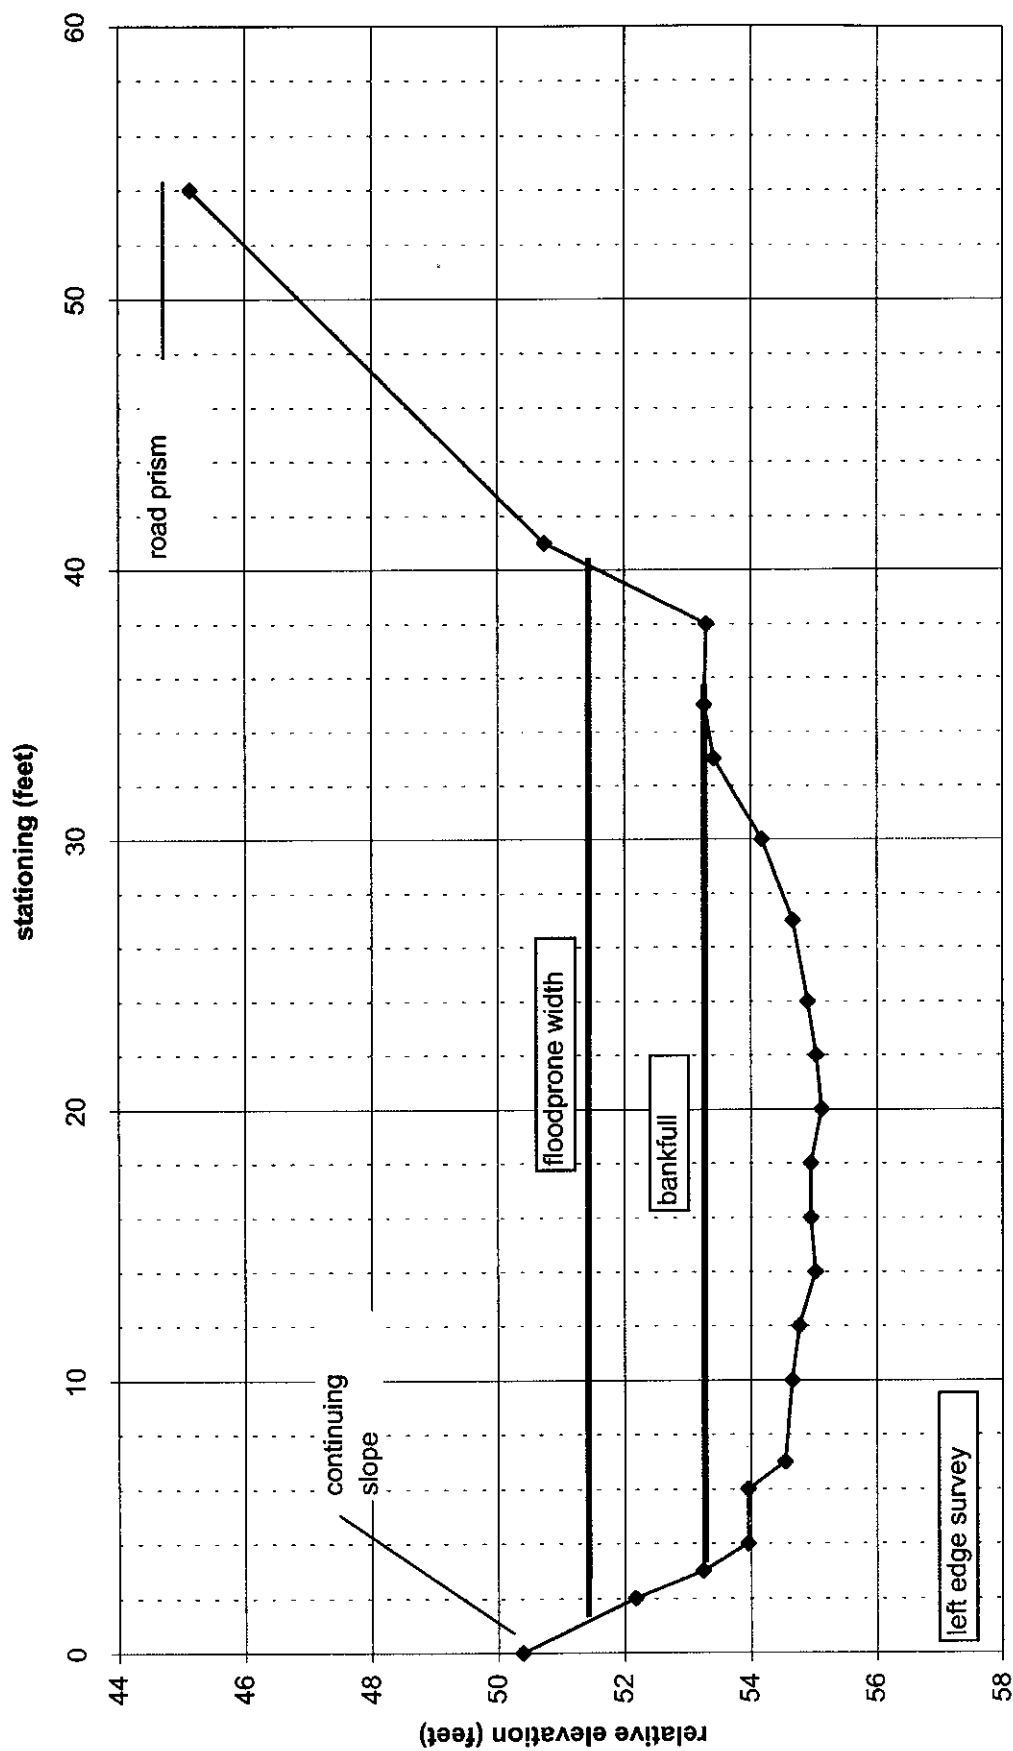
West Fork Jarbidge us of Jack Creek Cross section plot

<u>Pools</u>	Small pocket, scour, and backwater pools. Habitat and hydraulic diversity associated with large substrate elements.	
<u>Rosgen Classification Data</u>		
<u>Cross section form</u>	Uniform section with inset floodplain surface	
<u>Bankfull width</u>	32 feet	
<u>Mean bankfull depth</u>	1.5 feet	
<u>Maximum bankfull depth</u>	1.9 feet	
<u>Floodprone width</u>	39 feet	
<u>Bed slope</u>	0.018	
<u>Bankfull slope</u>	0.019	
<u>Bed materials (D50)</u>	28 mm	
<u>Sinuosity</u>	1.1 est	
<u>Width/Depth ratio</u>	21	
<u>Entrenchment ratio</u>	1.2	
<u>Rosgen stream type</u>	F4	
<u>Summary</u>	<p>Reach is characteristic on long channel segment from downstream of Mahoney guard station to confluence with Deer Creek.</p> <p>Reach has high stability and does not exhibit scouring or deposition on high surfaces from 1995 flood. Road chronic sediment source throughout reach.</p> <p>Reach is dominated by fluvial processes, but hillslope inputs of large substrate form key component of channel.</p>

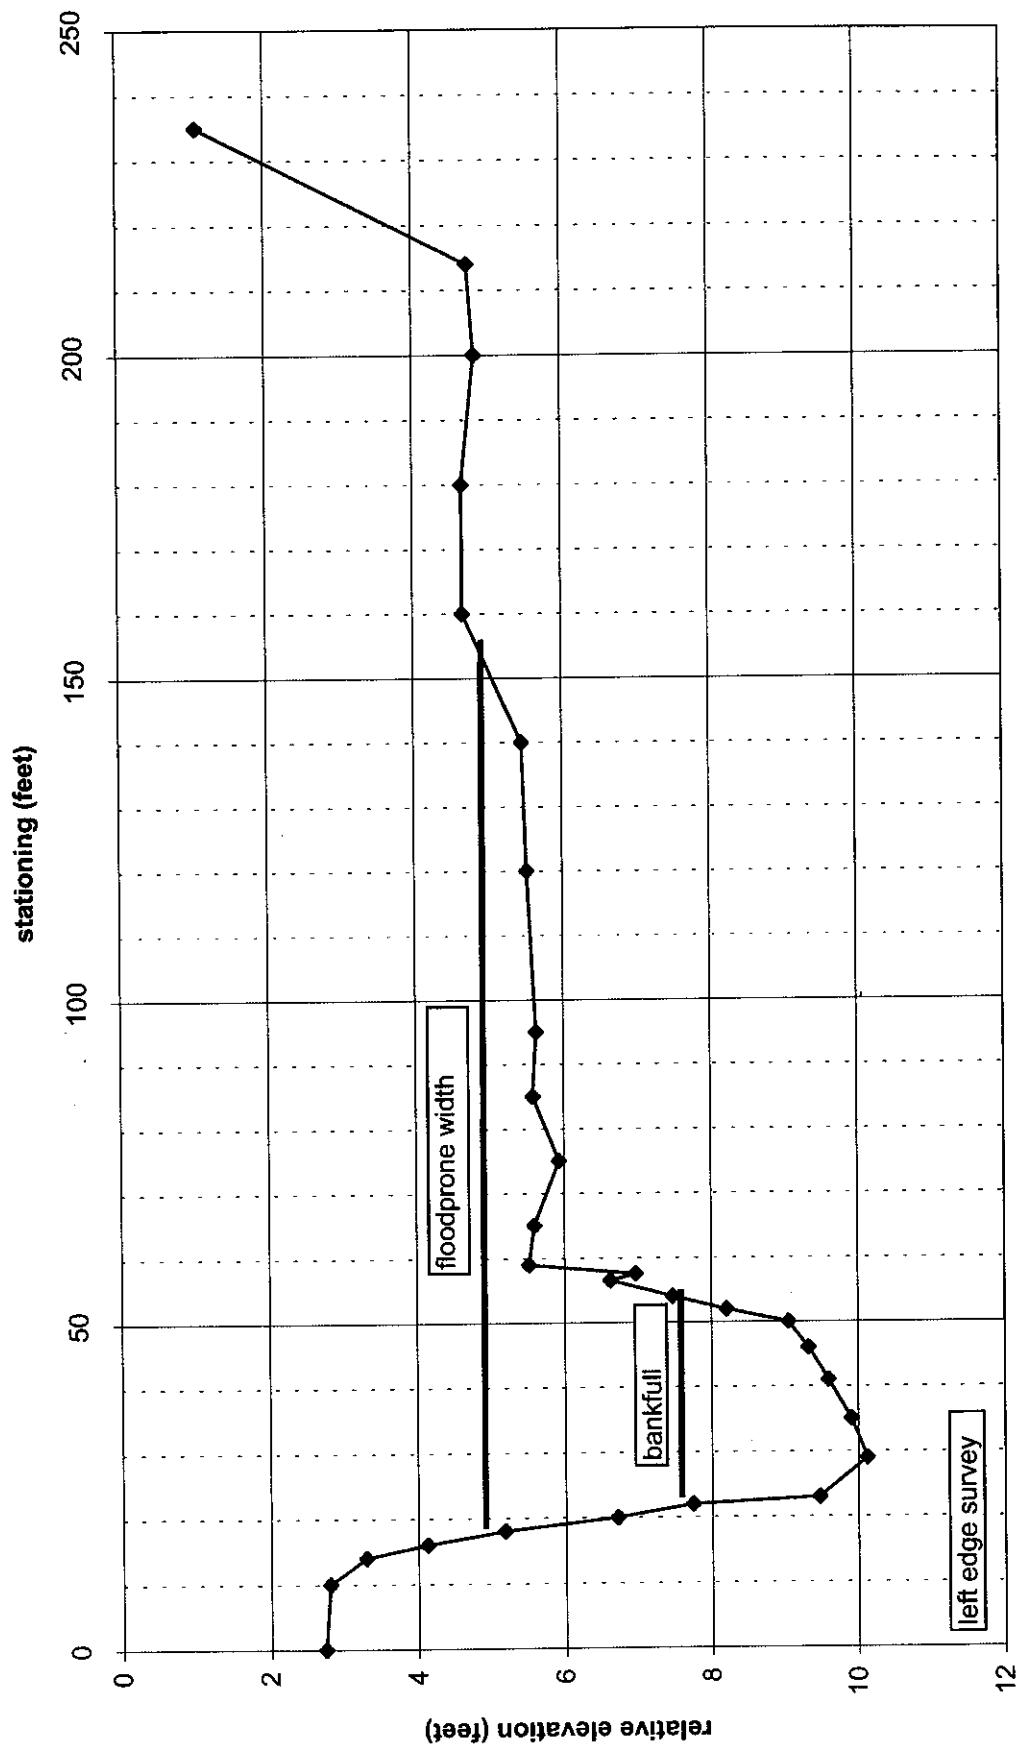
East Fork Jarbidge ab Robinson Creek Cross section plot

<u>Reach/Length</u>	East Fork Jarbidge River ab Robinson Creek	300 feet
<u>Survey Date</u>	7-Nov-01	
<u>Stream Order/ Reach Elevation</u>		
<u>Geomorphic Setting</u> Wide alluvial valley with multiple terrace surfaces. Historic beaver complexes observed throughout valley floor. Do not see large sediment storage zones. Channel intermittently flows over bedrock. Moderate grazing impacts and potentially historic impacts through reach.		
<u>Reach Geomorphology</u> Straight reach with bedrock forming bed up and downstream of survey reach. Six to 10 inch cottonwoods on terraces bounding channel. Active channel has limited access to valley width during low recurrence interval floods. Limited bar development in reach. Scattered large boulders through reach. Channel appears moderately incised. No direct evidence for scouring or deposition on high surfaces during recent flood history.		
<u>Bank Stability</u> Banks have a high percentage of riparian vegetation and are stable. There are scoured bank margins which are minor sediment sources.

<u>Woody Debris</u> Limited in channel wood accumulations were observed, but wood recruitment potential is high. There are large area with shrub riparian vegetation.		
<u>Pools</u> Scour and pocket pools occur in association with inchannel boulders. Trench pools occur in most areas with a bedrock channel. Larger cross channel width pools related to channel planform are common.		
<u>Rosgen Classification Data</u>		
<u>Cross section form</u>	Deep run with some backwater from downstream increase in bed elevation	
<u>Bankfull width</u>	32 feet	
<u>Mean bankfull depth</u>	1.8 feet	
<u>Maximum bankfull depth</u>	2.6 feet	
<u>Floodprone width</u>	138 feet	
<u>Bed slope</u>	0.009	
<u>Bankfull slope</u>	0.008	
<u>Bed materials (D50)</u>	27 mm	
<u>Sinuosity</u>	1.3 est	
<u>Width/Depth ratio</u>	18	
<u>Entrenchment ratio</u>	4.3	
<u>Rosgen stream type</u>	C4	
<u>Summary</u> Greatest observation of macroinvertebrates observed in this reach when pebble counts completed. Fluvial processes dominate in reach.
